Manhole Inspection Summary

Manhole # S09AA2030MH

Insp Date: **9/28/06 11:10 AM**

Location Address: **2627 GLEN AVE**

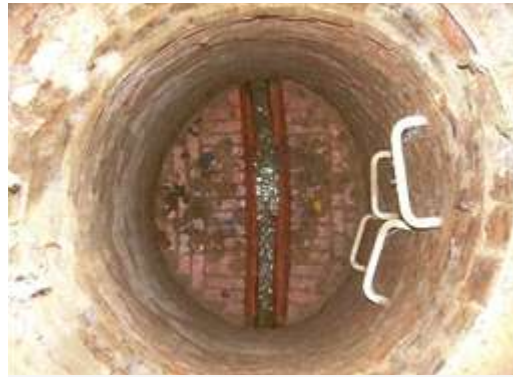
Top View

Bench ☒ Exists Material: **Brick** ☐ Parged ☒ **Debris** (not Condition related)

Bench debris.

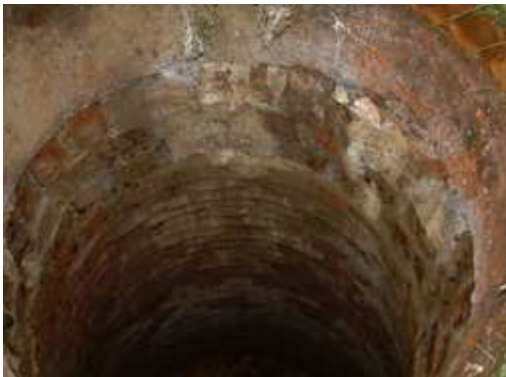
Defect

Frame Offset: **0** (in.) Condition: ☐ Sound ☐ Cracked ☒ **Leaks**

Infiltration: ☐ None ☒ **Joint** ☐ Cracks ☒ **Mortar** ☐ Roots ☐ Wall

Infiltration: ☐ None ☐ Joint ☐ Cracks ☒ **Mortar** ☐ Roots ☒ **Wall**

Frame leak, Adjustment and Corbel infiltration.

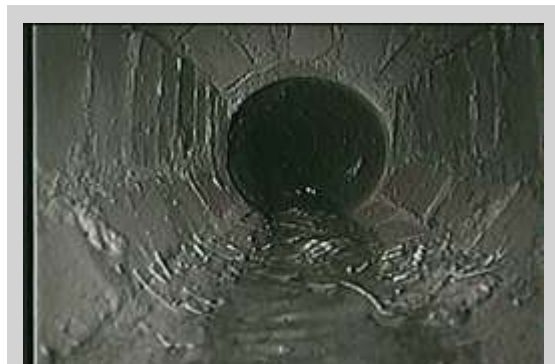
Pipe Out @ 12 O'Clock

Pipe Material: **Clay** ☐ Pipe Lined

Invert Depth: **8.73** (ft.) Flow Characteristics: **Slow**

Infiltration: **None** Pipe Seal Cond: **Unknown**

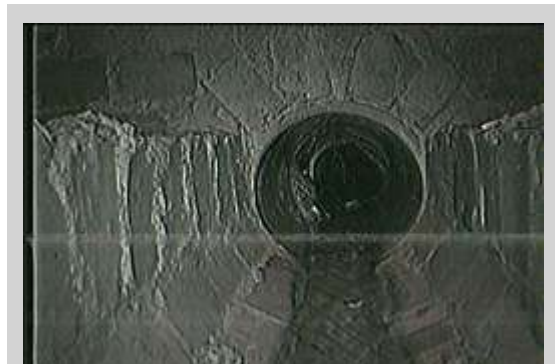
Pipe In @ 6 O'Clock

Pipe Material: **Clay** ☐ Pipe Lined

Invert Depth: **8.68** (ft.) Flow Characteristics: **Slow**

Infiltration: **None** Pipe Seal Cond: **Unknown**
